Bulletin No.: PIC5779H Published date: 07/17/2017

## PIC5779H Information On Preparation / Washing To Avoid Damaging Bright Aluminum Moldings

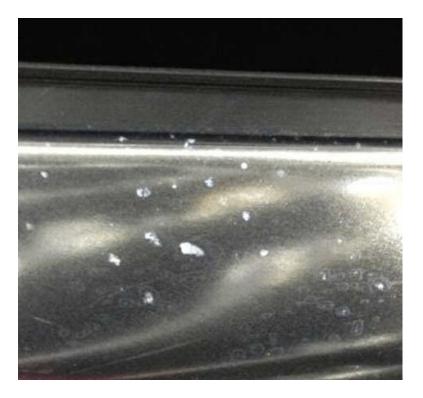
Important: Please ensure this information is reviewed with vehicle owners. In order to avoid damage that may not be covered by your warranty, it is recommended that a non-alkaline solution be used for preparation & washing of the Bright Aluminum Moldings.

If a cleaning solution greater than 11.0 pH is used, the following procedure must be used:

- Prewash the vehicle to bring moldings to room temperature.
- Apply cleaning solution out of the sunlight at room temperature.
- Rinse moldings with clean water within 5 minutes of application of cleaning solution.
